Case Study

How SSE used site engineers, continuous online vibration and condition monitoring systems with specialist remote diagnostic engineers support

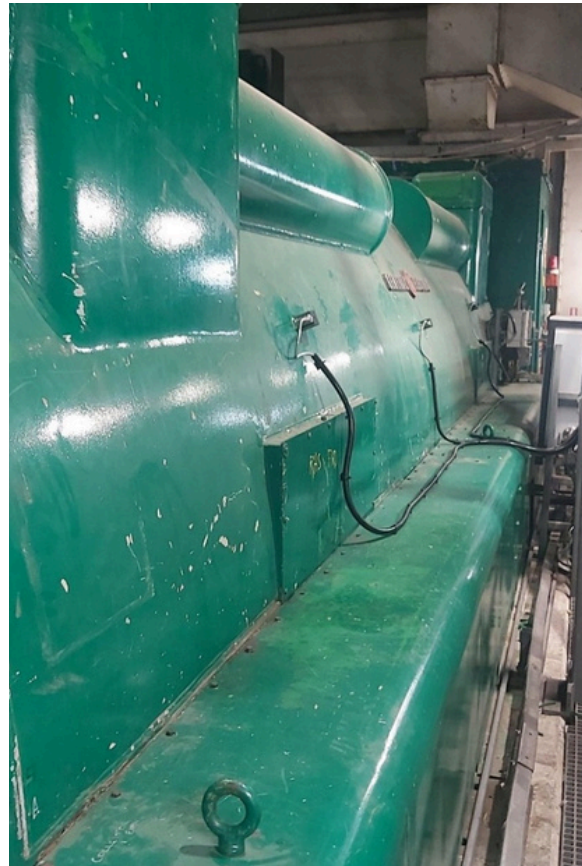
Figure 1: Temporary vibration sensors attached to the generator casing.

The remote specialist engineers at SSE EPC requested site engineers to install additional vibration sensors to monitor generator casing vibrations (see Figure 1), and connect them to the installed Beran PlantProtech™ Analyser.

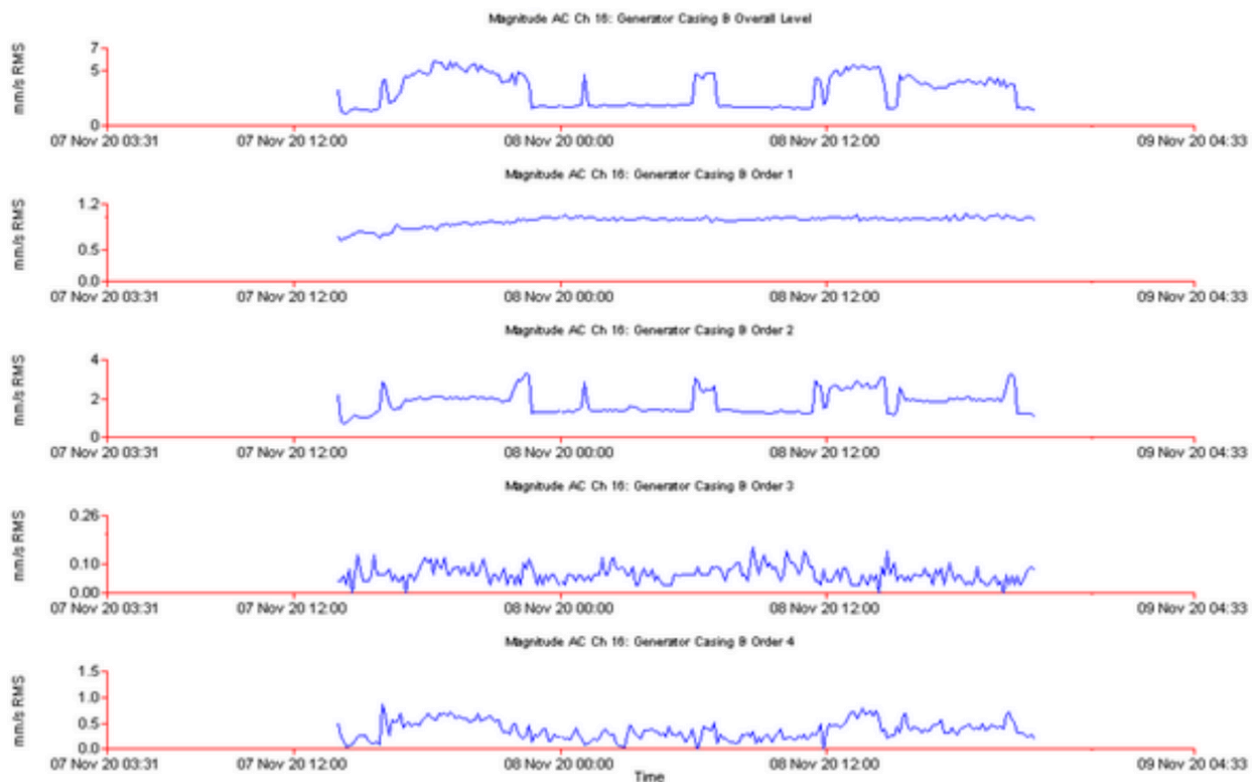
Figure 3: Shows overall order 1, 2, 3 and 4 vibration levels plotted against time.

Figure 3 shows the vibration components plotted against time from one of the temporarily installed generator casing sensors. The reader can see that the change in the overall level (top graph) correlates to the change in Order 2 (2x running speed), Order 1 (1x running speed), order 3 (3x running speed) and order 4 (4x running speed) levels, with negligible change.

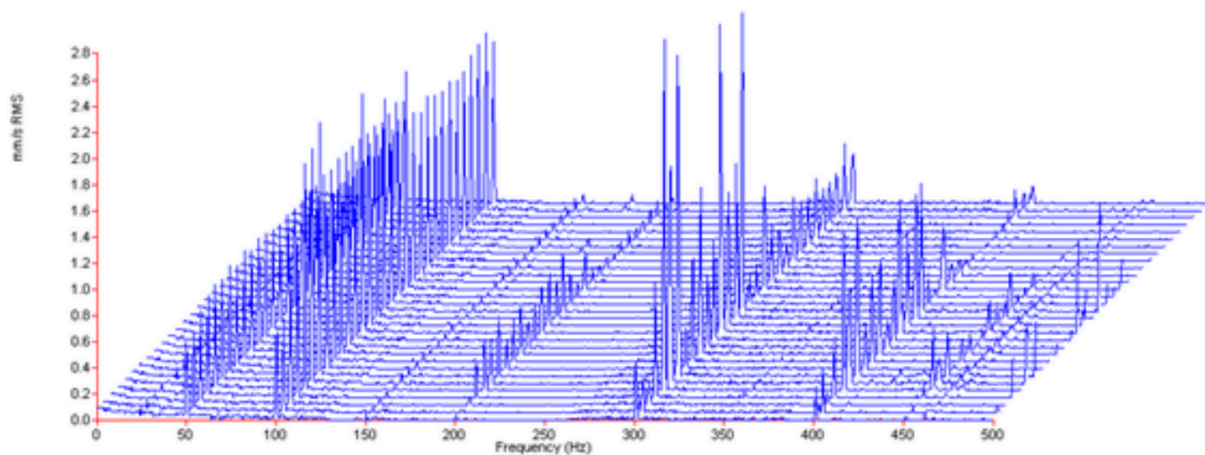
Figure 4: Shows frequency spectrum from generator casing sensor.

By reviewing the data on the installed Beran PlantProtech™ Analyser, engineers quickly saw that the predominant frequency component of the casing vibration was 100Hz and its harmonics, even though the noise was intermittent. The generator at this site is a 2-pole design, so twice the line frequency is observed.

Figure 4 shows the frequency spectrum from one of the installed casing sensors. This machine generates electricity at 50Hz, and we can see the order 1 (1x) component in the frequency spectrum. Additionally, we can see a larger vibration component at 100Hz, order 2 (2x running speed) and harmonics at 200Hz, 300Hz, and 400Hz.

SSE's concern was the cause of the change in machine vibration characteristics, which was unusual and required investigation at the next opportunity. The vibration symptoms suggested either some looseness or impacting within the generator.

EPC engineers advised investigating the generator stator and frame mounting area. Engineers found some looseness within the stator to core mounting, requiring an adjustment to the generator "belly band".

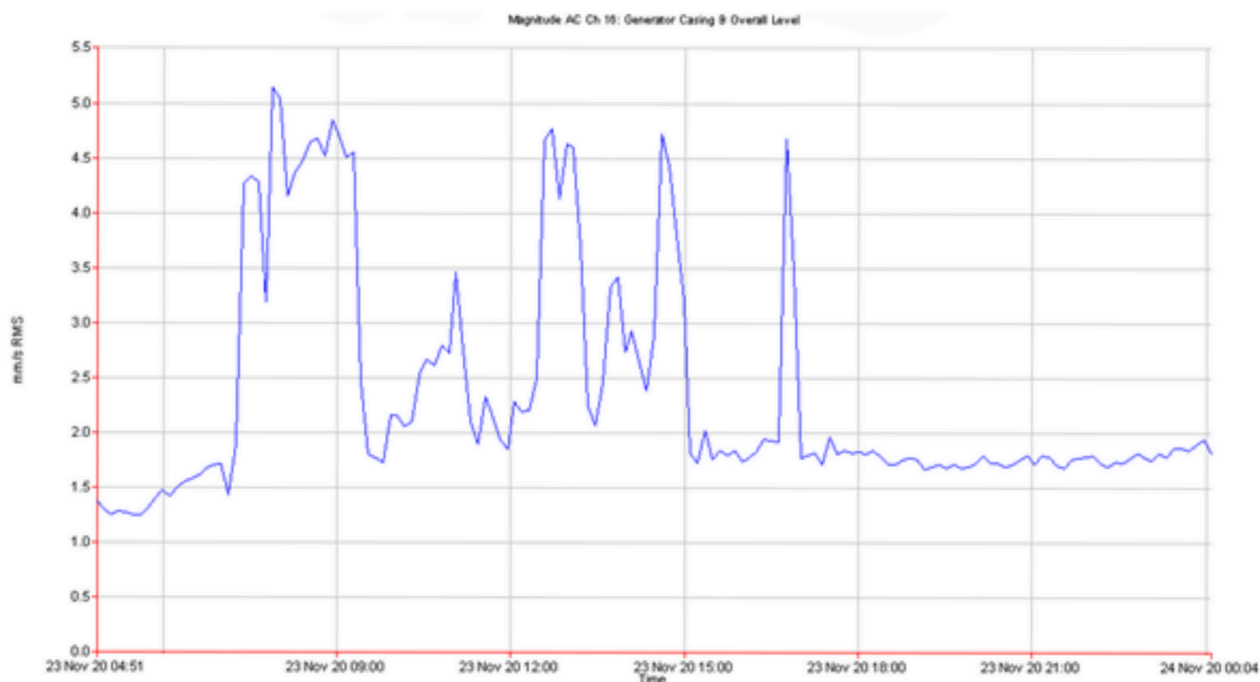
Figure 5: Shows overall vibration trend for 20 hours showing intermittent nature of issue.

As stated earlier, the experienced fault was intermittent, as seen in the overall vibration level shown in Figure 5 for less than a 24 hour period.
